## RESTORATION

During the 1960s PRR sold two MW cars, without trucks, to Marion W. Parks, a local Urbana building supply dealer and coal yard. They were used as an office and for storage. In 1999 the Parks family donated the cars to the Champaign County Preservation Alliance. One was moved in 2000, to be restored for then North Lewisburg's in-progress bike trail on abandoned Erie-Lackawanna Railroad roadbed, called the Simon Kenton Trail. (The second car was too far gone to restore, and was scrapped.) The restoration has been co-sponsored by the Simon Kenton Corridor, the Simon Kenton Pathfinders, and the Champaign County Historical Society.

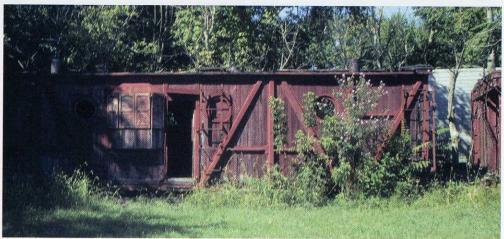
Derelict Urbana NX23, August 31, 1999. (Rich Burg photos) ▲

The first major job undertaken was attaching the ceiling. The original metal roof trusses had wood attached to them at the ceiling level. These had deteriorated, so the ceiling was sagging in the middle, where the ceiling boards overlapped. When this car was on West Court St. It sat on railroad ties, enabling termites to get into the floor, and repairs were necessary. There were two original door latches, one brass and one cast iron. We hope to locate two additional latches and install them on all doors.

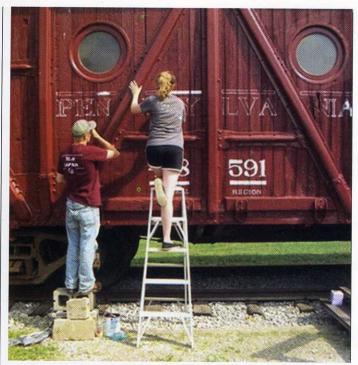
Students lettering the NX23. (Ken Davis collection)

Hi-Point Career Educational students have restored three doors, built another, bead blasted the window rings, and cut out identification stencils for painting the exterior. Volunteers placed primer paint on the exterior and the car was spray painted with a final coat. The Urbana High School FFA spent two days after school painting all of the

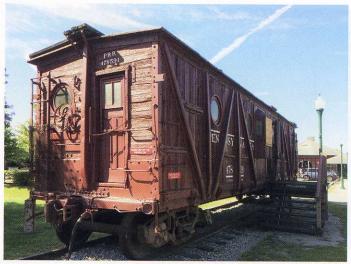
▲ ▼ Completed restoration, August 23, 2016. The city of Urbana and many individuals played a huge part in restoring the NX23. (Ron Widman photos)

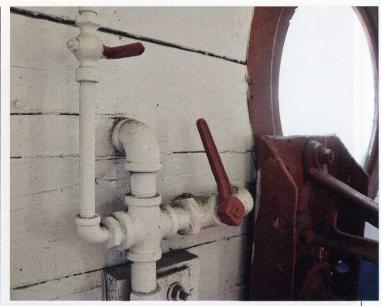
Brake valves are located beside the two interior brake wheels. April 12, 2017. (Ron Widman photo)

Behind the door next to the coal bin is an air gauge that displayed the train brake air-pressure.

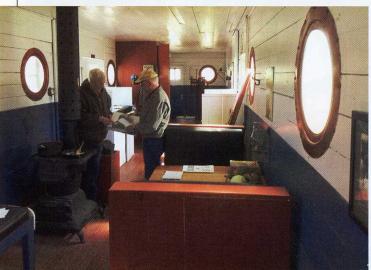
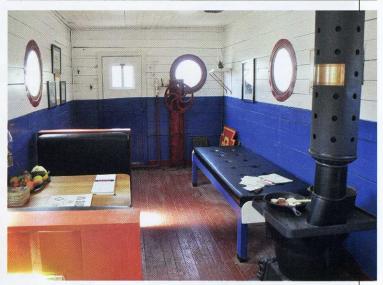
Interior, April 12, 2017. In one view, Ken Davis and Gary Salzgaber look over a steam locomotive calendar photo. (Ron Widman photos)

We installed three lockers, one booth, one bed, two bays, and a sink. We also installed five original Johnson Mfg. caboose lamps, produced across the street from the NX23 and PRR depot.

The benches along the interior sides were installed in the 1950s when the car was used for maintenance-of-way. The four vents, we believe, were installed about the same time.
